Phase I Environmental Site Assessment Report

**7270 Hamner Avenue
Eastvale, California**

**Converse Project No. 17-16-130-03
August 4, 2017**

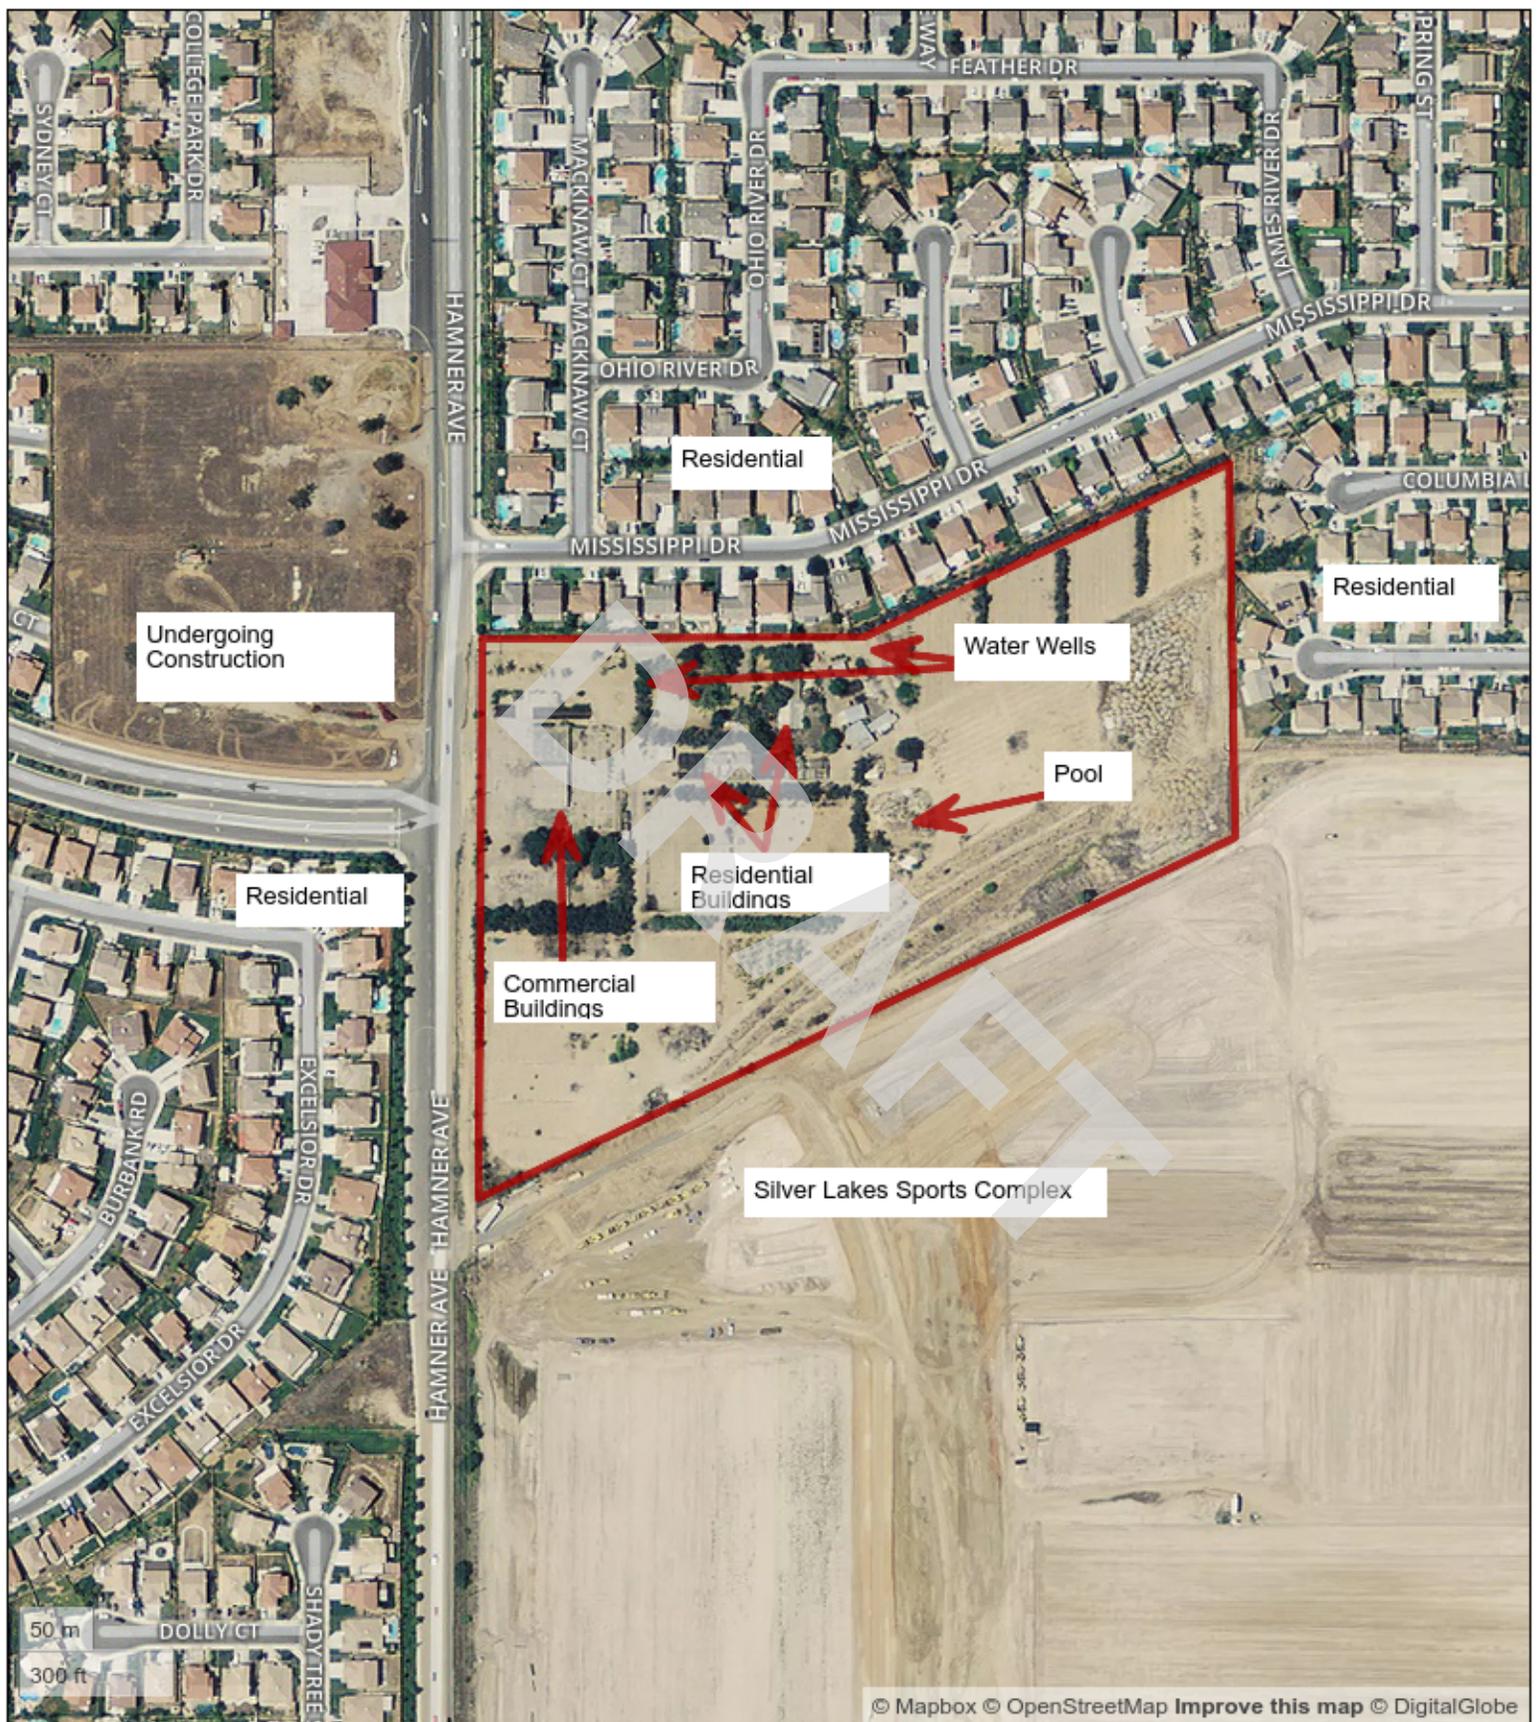
Figure 2

Property Map
7270 Hamner Avenue
Eastvale, California

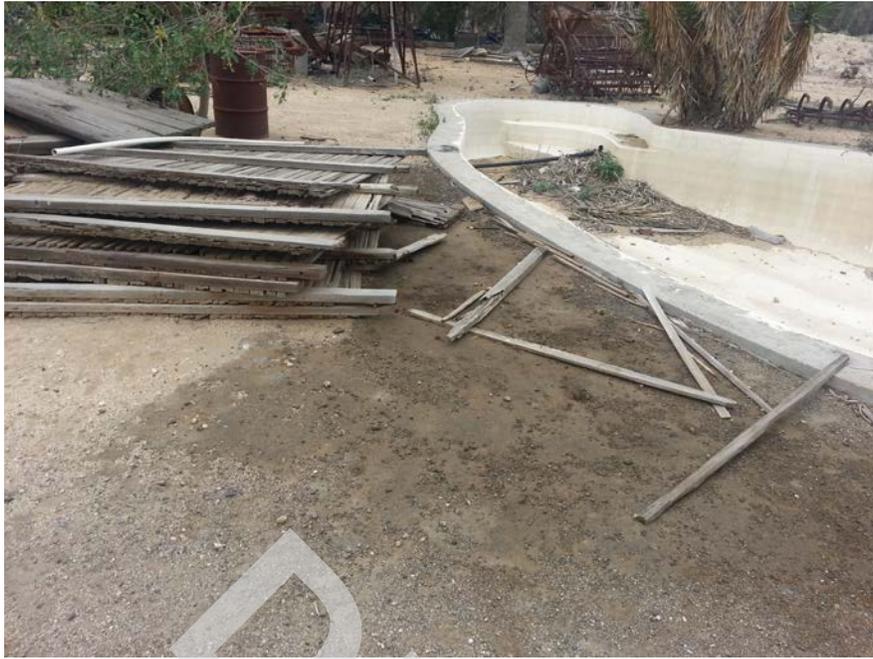
7. View of the petroleum stained area near the dilapidated swimming pool.

- Converse observed a large area of stained soil near the dilapidated pool during the Property reconnaissance in May 2014. Converse recommends the excavation and disposal of the soil in accordance with applicable regulations. Converse further recommends the collection of confirmation soil samples at the conclusion of the soil excavation.

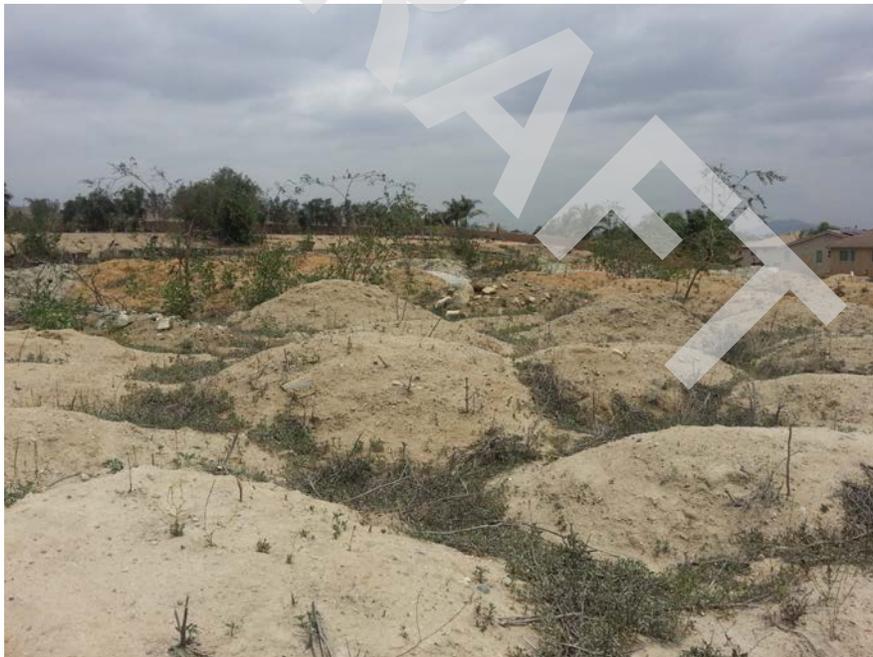
8. View of the fill piles on the east side of the Property.

- Several fill piles and a mound of soil near the garages was observed during the Property reconnaissance in May 2014. The origins of the soil were not disclosed to Converse. Converse recommends environmental screening of the undocumented fill for either re-use or disposal.
